AIA Document G704™ - 2000**Certificate of Substantial Completion****PROJECT:**

(Name and address)
Oak Creek Village Apartments
2324 Wilson Street
Austin, Texas 78704

CONTRACT FOR: General Construction
CONTRACT DATE: May 21st, 2014

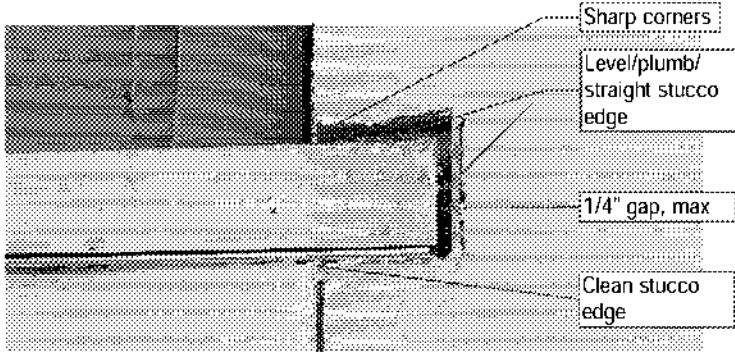
BCS to issue PCO.
General, Balconies	05	<p>The stucco work surrounding the aluminum balcony floor edge is substandard. The stucco edges are uneven, rough, and not level/plumb. The gap between the floor edge & stucco often exceeds 1/2". Repair stucco edges & trim to create 1/4" max open joint.</p>

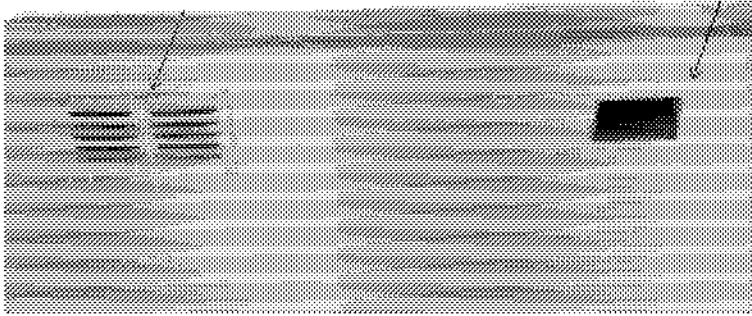
Location	Item	Description	Photo
General, Balconies	06	Seal edges of soffit vent covers & outlets to soffit board, paint.

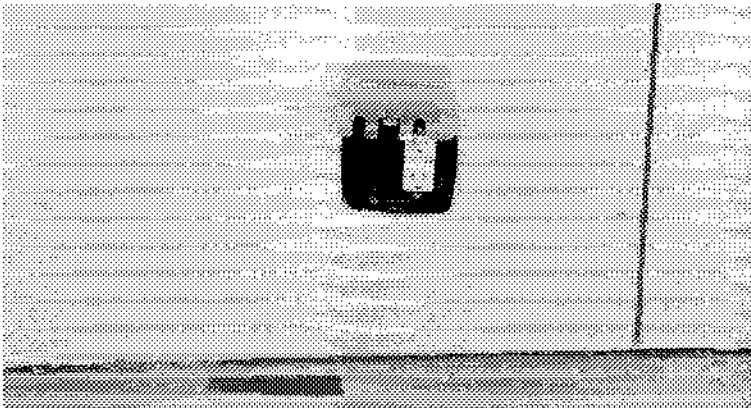
Location	Item	Description	Photo
General, Ext Outlets	08	Some exterior outlets are not level or flush against the wall.

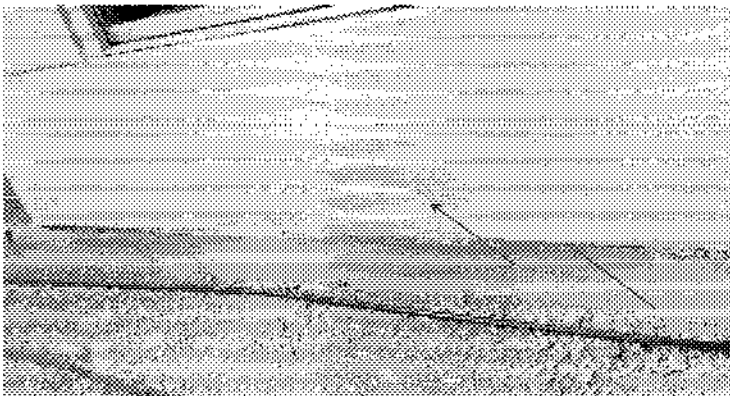
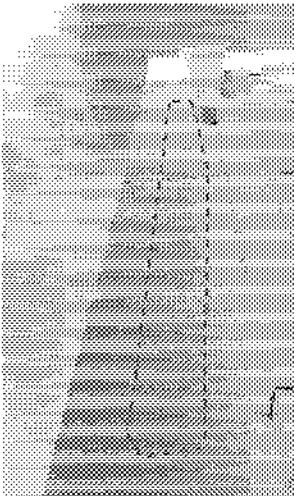
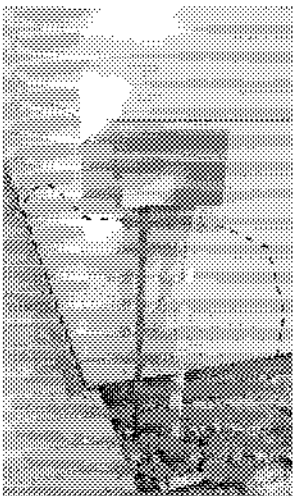
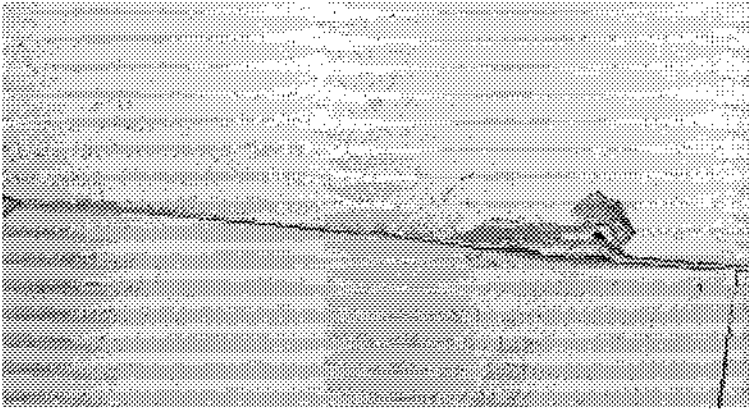
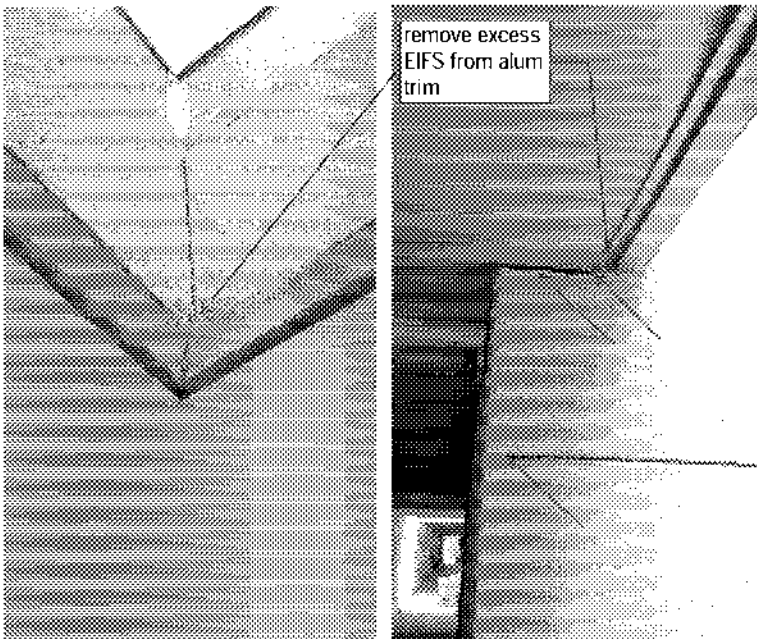
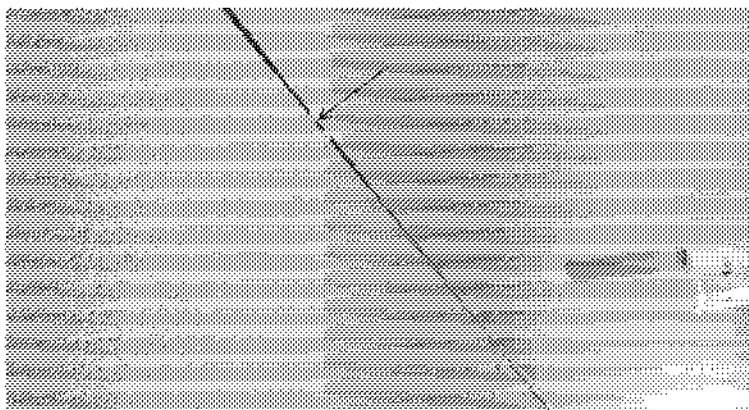
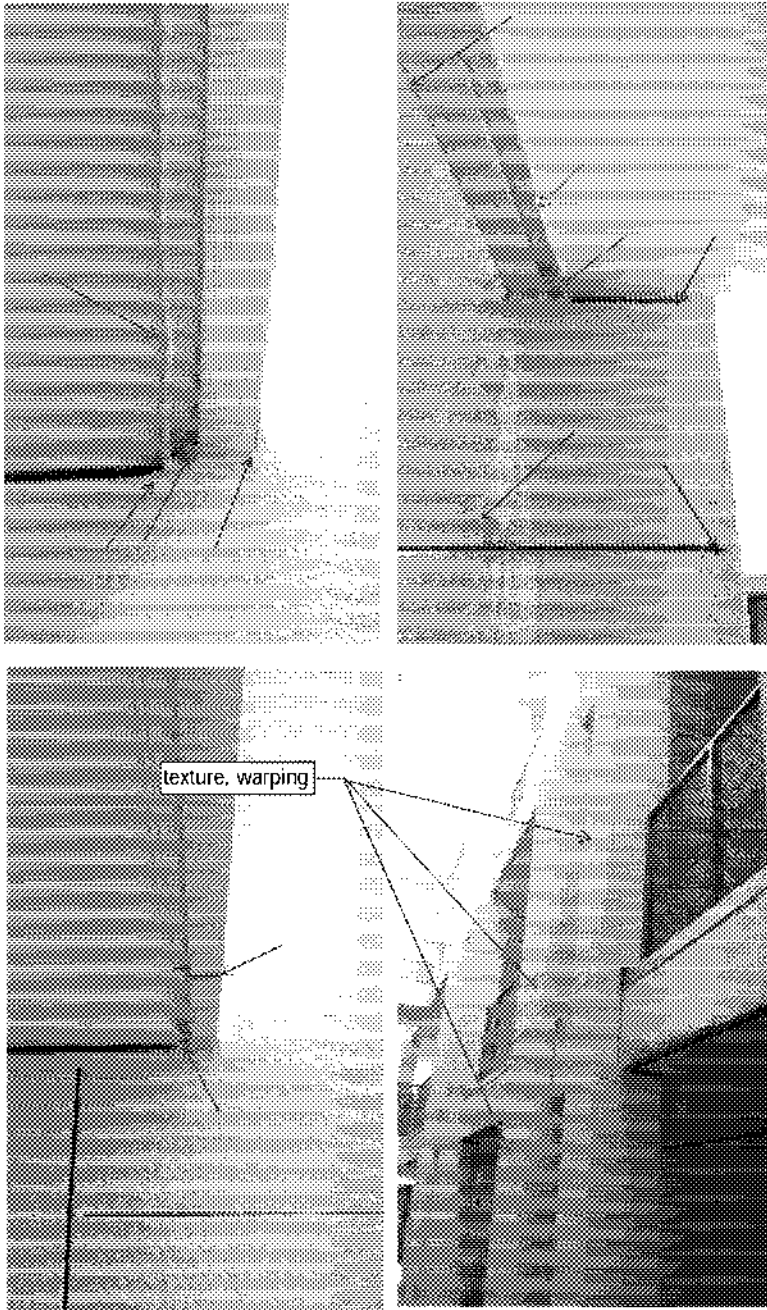
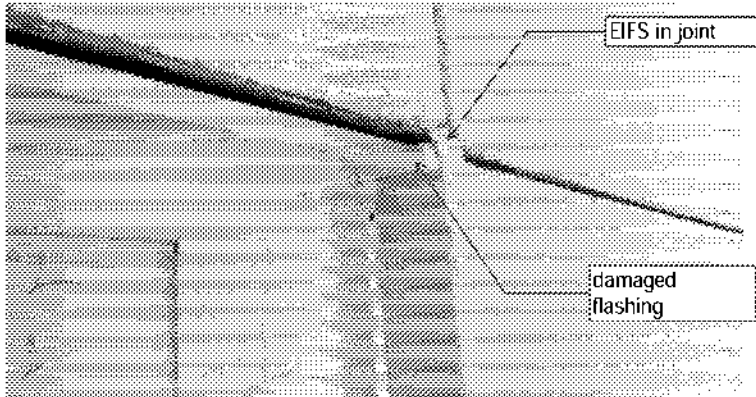
General, EIFS	09	<p>Typical EIFS issues:</p> <ul style="list-style-type: none">- Material in ends of reveal joints- Texture inconsistency & flaws - divots, drops, scratches, etc- Bottom edge flashing clogged with EIFS debris- Run-off staining- Concrete work splatter- Damaged edges- Reveal joints not installed straight/level/plumb

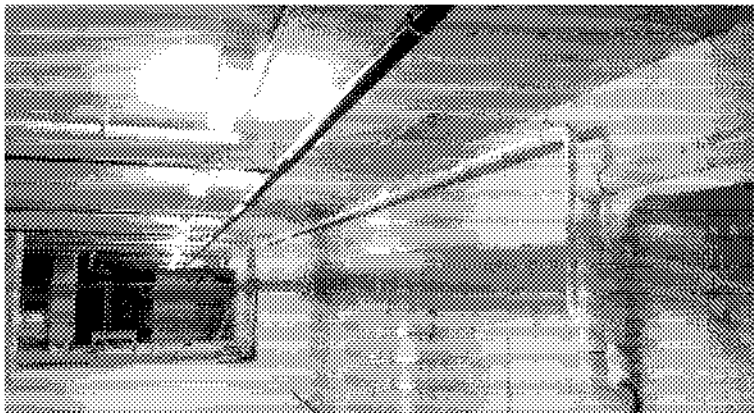
Garage Lighting 10

On G1, the fluorescent strip accent lights are positioned per plan, approximately 10' from the west wall that they're intended to wash. However, due to the placement of a sprinkler pipe, there's a large shadow line interrupting the 'wall wash' effect. BCS recommends shifting either the lighting (west 2') or the sprinkler line (east 2'), to move that shadow line down to the floor. Either option is acceptable - the least expensive & schedule-impacting is our preference.

BCS to issue PCO

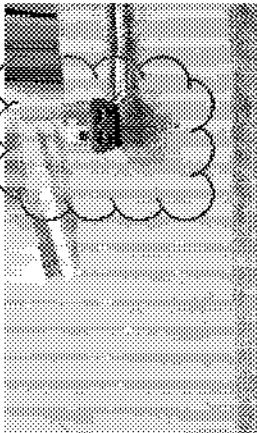
Location	Time	Observation	Notes
Garage Interior	01	<p>All locations: Column-mounted electrical devices appear to protrude more than 4", below 80" AFF, which is a TAS/ANSI accessibility violation.</p>

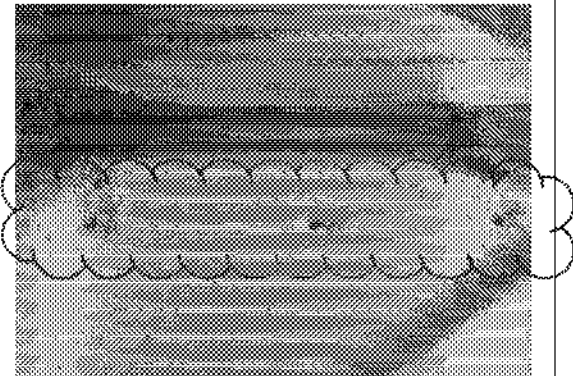
Garage Interior	02	<p>Rebar visible in concrete floor divots @ bottom of north stair, level G1</p>

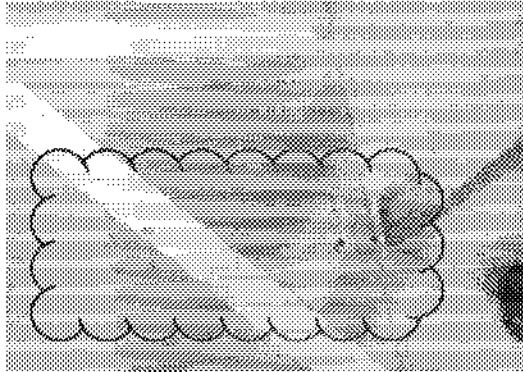
Garage Interior: G2	03	<p>Floor divots near B-9, level G2</p>

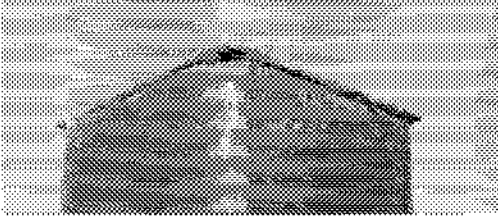
Building 4, South Stair, Level 5	08	Cap @ top of structural steel post is roughly cut & welded with sharp protruding edges; grind smooth & flush w/ post

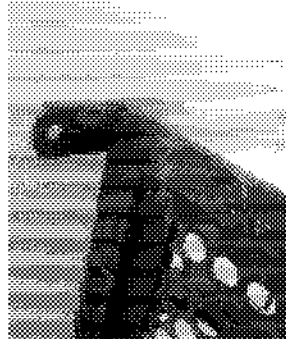
Building 4, 10 South Stair, Level 6		Top level railing adjacent to stair does not attach to stucco wall - railing is loose & weak. Modify top bracket to allow bolted connection to stucco wall, below metal cap. Do not cut parapet cap.
-------------------------------------	--	--

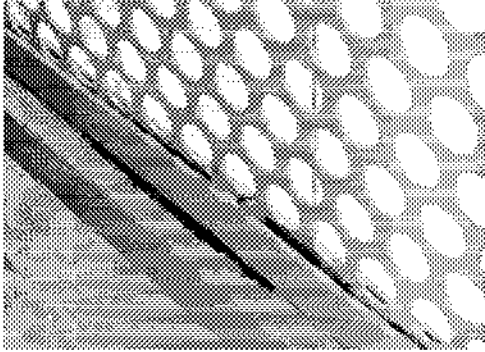
Location	Item	Description	Photo
Building 4, 12 North Stair, mid-level landing between 3 & 4		Rust or rust-colored liquid stain @ base of guardrail

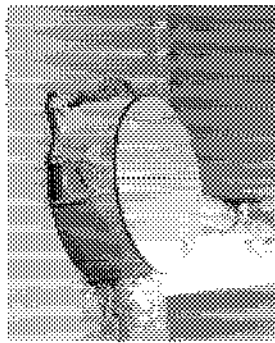
Building 4, 13
North Stair

- Handrail paint scratched, typical for all stairs
- The square columns are un-painted where they abut the fascias at each level; this is likely to continually cause rust-staining & corrosion problems
- Conduit to lighting is typically only 1/2 painted: paint all of it, to the fixture.
- Remove paint from light fixtures & adjacent walls

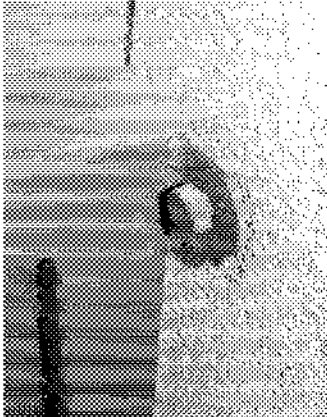
Building 4, 15 North Stair, Level 2	15	Similar to Item 14 above. Railing isn't rigidly secured

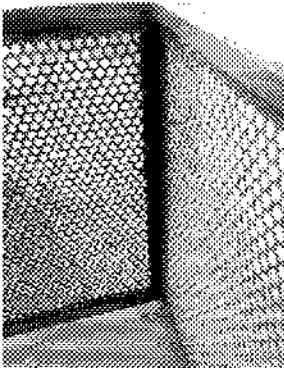
Building 4, 16 North Stair, mid-landin g between 1&2	16	Bowed perforated panel @ connection to corner post

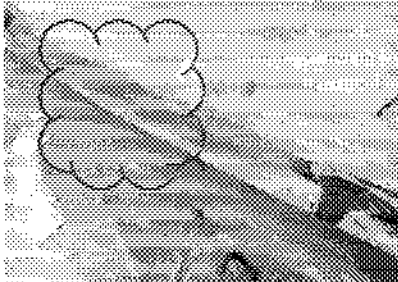
Building 4, 17 North Stair, Level 1	17	The hand rail from Level 1 to the landing is damaged.

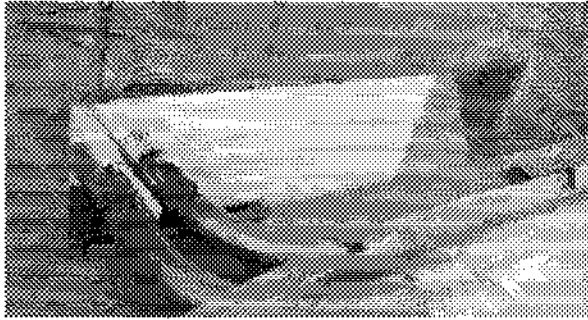
Location	Item	Description	Photo
Garage, G2	18	Large floor leave-out @ north end may require fall protection after all services are installed.

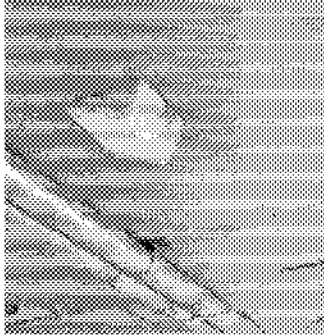
Garage, G2	19	Styrofoam & fill material falling through Podium deck opening

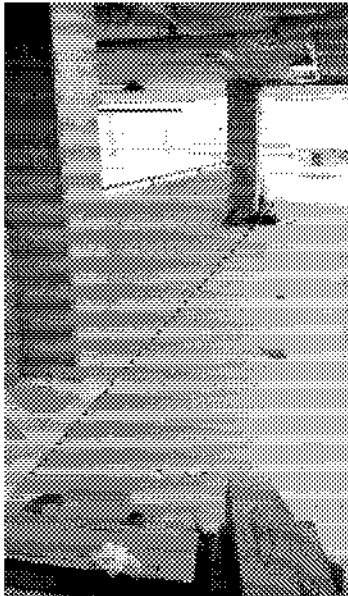
Garage, G2	20	Continue striping. Tie-in with striped crosswalk across vehicular entrance.

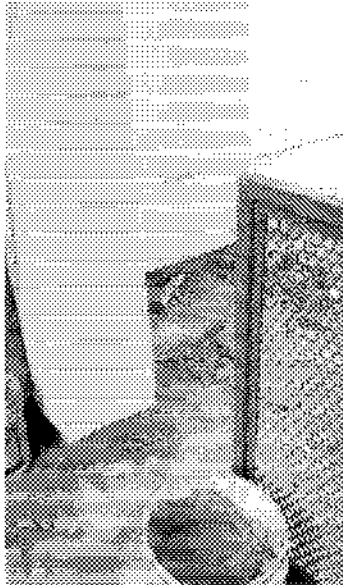
Location	Item	Description	Photo
Building 3 connection to Building 4, Level 3	21	The clear width of this opening, from catwalk to upper courtyard, MUST be 36" for AFD access requirements. Please confirm.

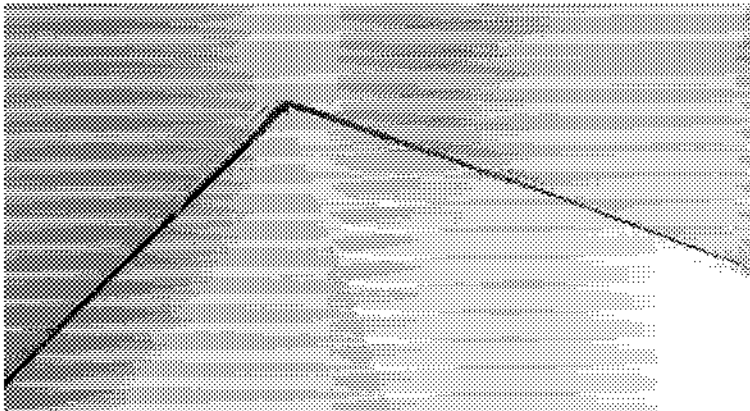
Exterior breezeways	22	Typical: reveal joint @ top of stucco wall below soffit is often out of level, wavy, debris-filled, paint spattered. Some cracking of stucco also occurring. BCS recommendation: Clean & paint this joint ceiling white, everywhere.
---------------------	----	---

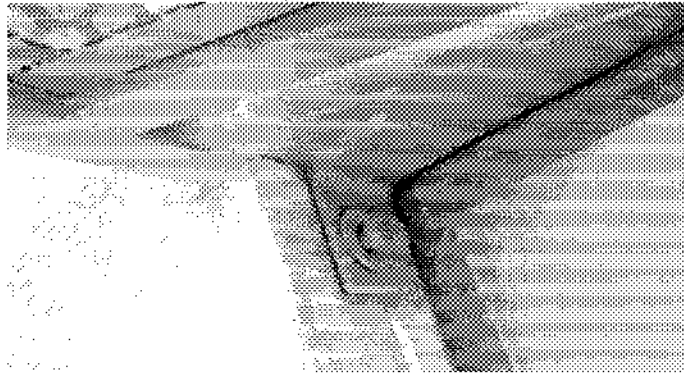
Exterior Stairs, Buildings 2&4	24	Typical: check bolted connections to Breezeway floor/ceiling fascia for rigidity & tightness. Several bolts were observed to be protruding & not fully seated, washers often overlap one another.
---	----	---

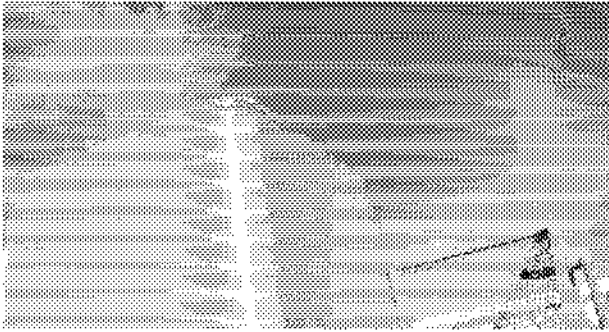
Location	Item	Observation	Photo
Building 2, 25 North stair, top landing		Cap @ top of structural column is roughly welded - grind smooth.

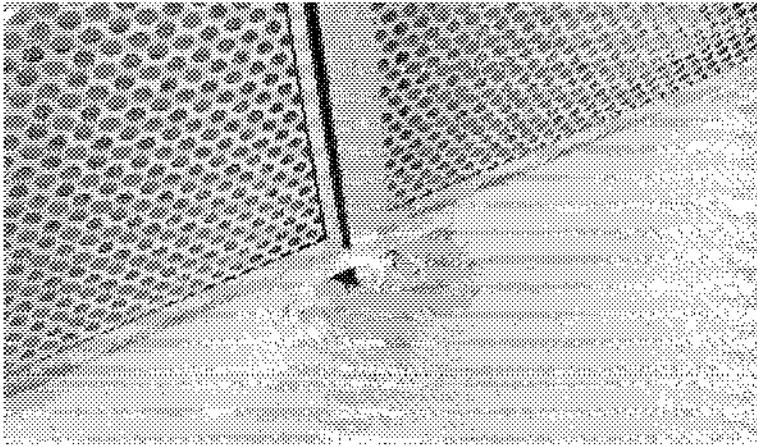
Metal Railings	26	Typical: concrete patches at posts are typically not level, not textured to match adjacent broom finished concrete, and concrete residue splattered on metal railings.

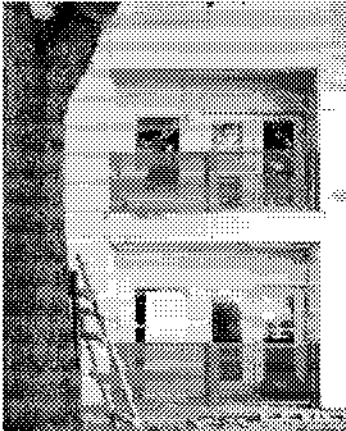
Wall Sconces, All Unit Balconies	27	Wall sconces are installed below 80" AFF, and protrude more than 4" from the back wall, which BCS believes is an accessibility violation.

BCS has relayed this concern to Terry Kitay for review and will pass along her ruling.

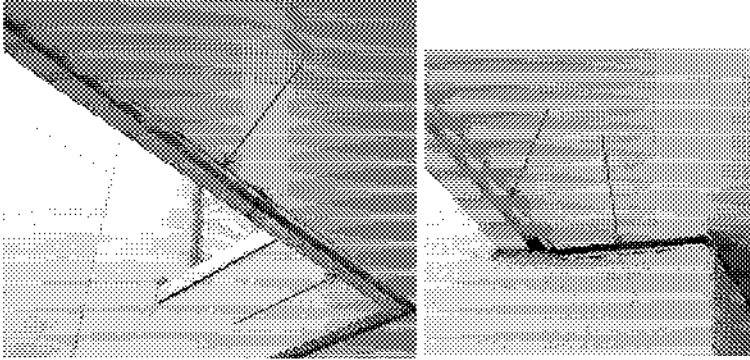
Location	ID	Problem	Action
Level 3 Breezeways Buildings B and D	01	Soffit trim @ breezeway and lightwell ceilings is dirty, scratched and bent, sloppy joint caulking and cracked ragged edge at adjacent cement board ceiling. BCS recommends cleaning free of marks and stray paint/caulking stains.

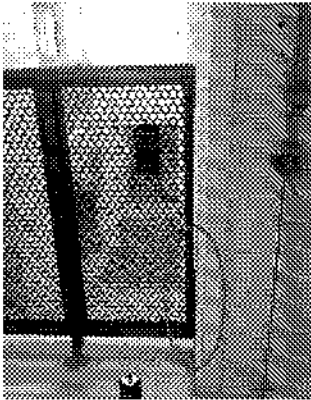
Level 3 Breezeway Building D	02	Guardrail @ unit D301 entry misaligned and not square with wall; bottom portion is buried in stucco. BCS suggests cutting guard back clear of wall and aligning with face of wall.

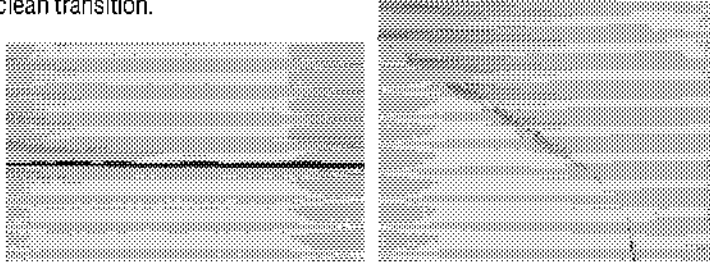
Location	Item	Description	Photo
Level 3 Breezeways Buildings B and D	04	Joint @ breezeway ceiling/wall transition often ragged and covered with excess stucco. BCS recommends cleaning ceiling surfaces and repainting for clean transition.

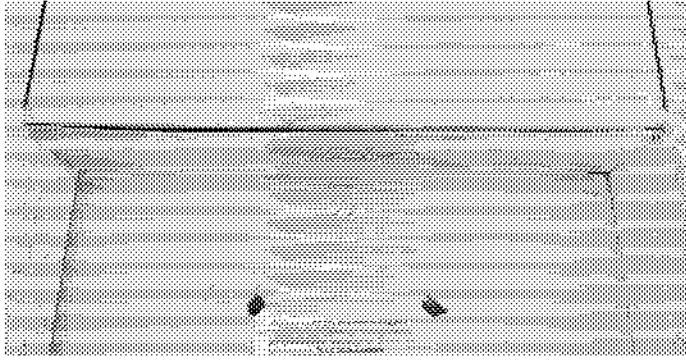
Level 3 Breezeways Buildings B and D	05	Trim @ unit entry door headers bent and chipped throughout.

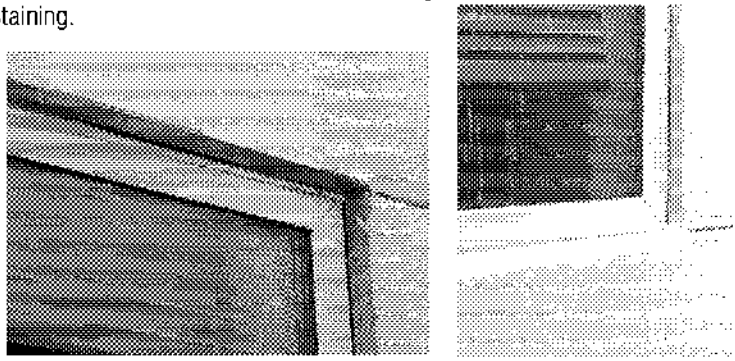
Level 3 Breezeway Building D @ Unit D301	06	Stucco around lightwell window for unit D301 is ragged and sloppy, with excess material on surround trim. Clean edges and trim surface free of staining.

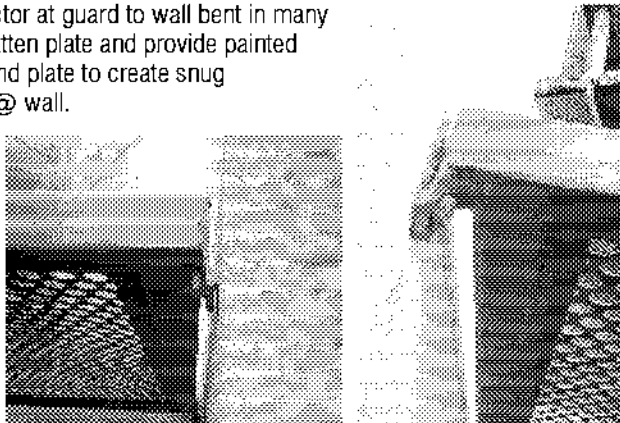
Level 3 Breezeways Buildings B and D	07	Plate connector at guard to wall bent in many locations; flatten plate and provide painted washer behind plate to create snug connection @ wall.

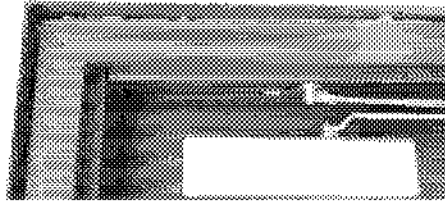
Location	Item	Description	Photo
Level 3 Breezeway Building D	11	Ragged and sloppy joint @ corridor door head reveal.

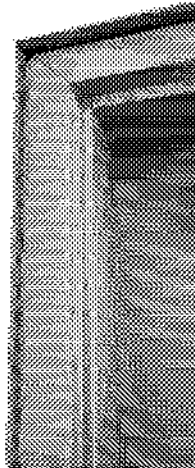
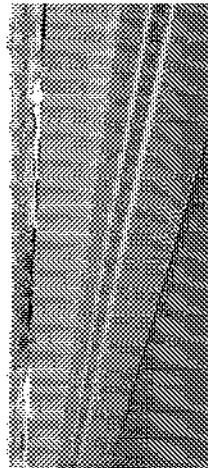
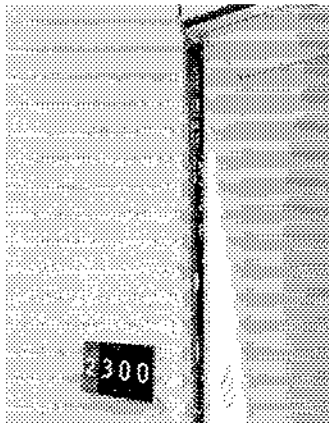
Level 3 Breezeways Buildings B and D	12	Exposed sheathing, caulking, and waterproofing barrier @ multiple door trim conditions. Trim, clean, and seal as required.	
---	----	--	--

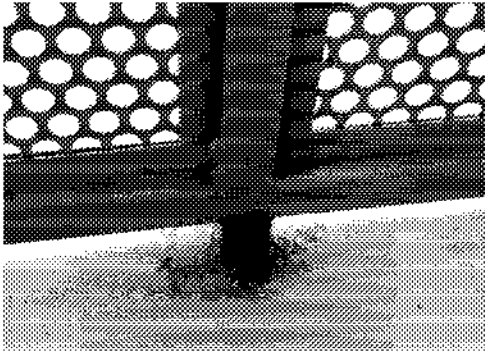
Level 3 Breezeways Buildings B and D	14	Open concrete and rust staining @ guardrail post in multiple locations. Patch opening and clean rust as necessary.

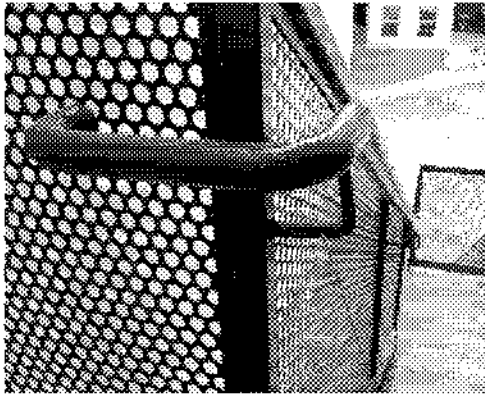
Level 3 Breezeways Building B @ Stair B North	15	Bent guardrail bracket @ Stair B North

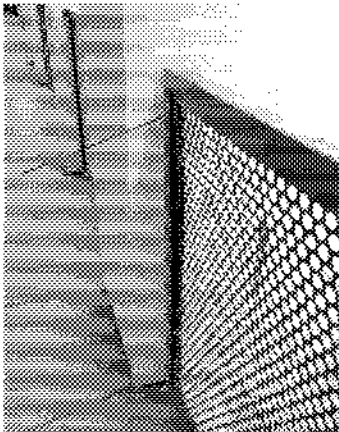
Level 3 Breezeway Building B	16	Guardrail adjacent to unit B303 is bent and bowing.

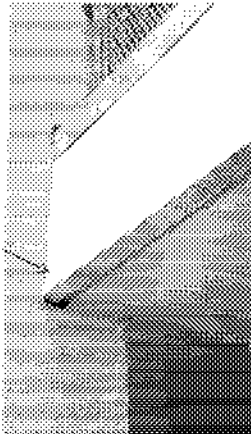
Level 4 Breezeway Building B	18	Face of breezeway soffit at Level 4 landing adjacent to elevator B out of alignment.

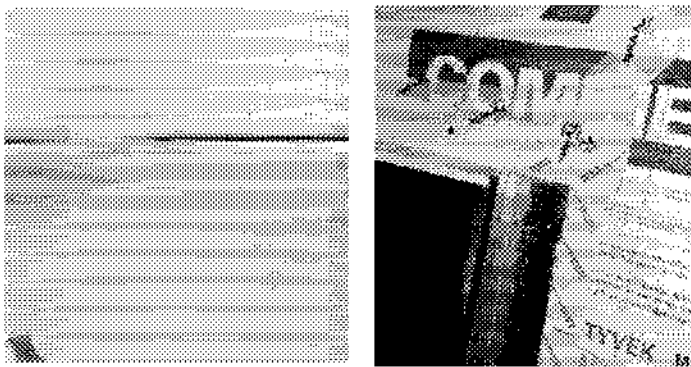
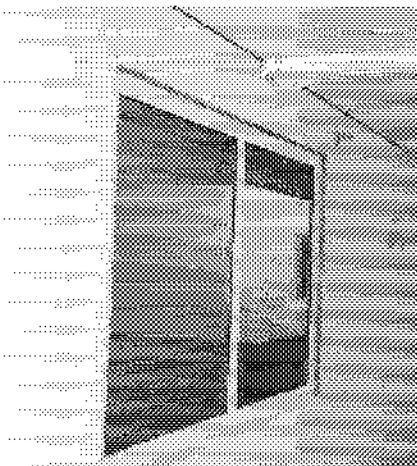
Location	Unit	Notes	Photos
Unit Entries, Phase 1B	#1	<p>Flashing above Unit 1B entry doors is being installed identically to problematic 1A entries.</p>

<p>Note: Window heads along corridors have stucco J-trim, no flashing, and they look great. Why are doors along the corridors treated differently?</p>

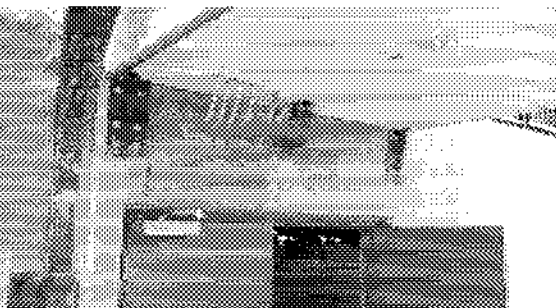
Garage, North side exterior	#2	<p>Paint exposed conduit, FS piping, and steel brackets 'railing gray'. Provide white escutcheon plates for soffit penetrations</p>

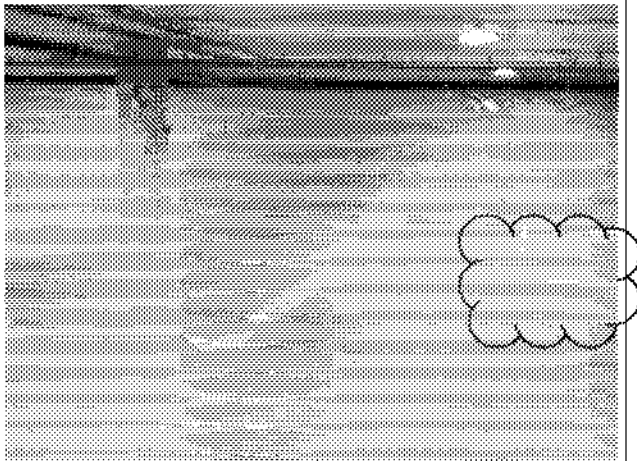
Garage, G1	#3	<p>One of the garage floor directional markers was observed to have an extra, incorrect arrowhead, directing traffic incorrectly.</p>

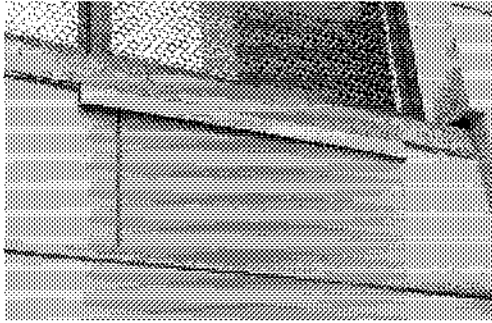
Location	Item	Description	Photo
Garage, North side exterior	#6	BCS reviewed a mock-up of Weis's proposed 'topping slab edge correction' flashing mock-up with Weis. BCS to issue final flashing detail, based on Weis's proposed design, with only minor modification for aesthetic concerns.

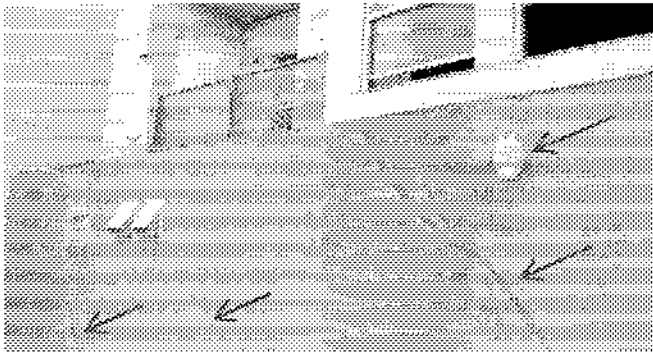
Location	Item	Notes	Action
Garage exterior, west	#1	<p>Confirm wall-mounted light is temporary, until wall packs above are activated. Also, repair large 'scar' marks across face of garage</p>

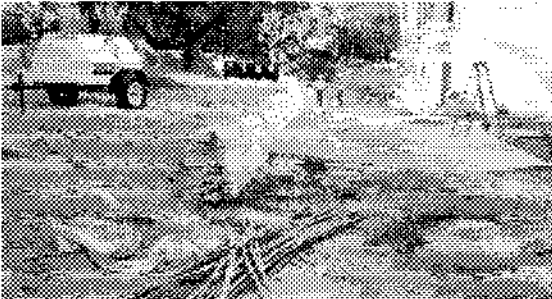
Pavilion Area	#2	<p>Retaining walls do not match design layout in a couple of locations:</p> <ul style="list-style-type: none"> - Low wall adjacent to parking garage south leg should be curved per PCO-49, PCO-45. Built straight.

<p>Discussed with Owner & Weis on site. The low wall will be re-built per the current design. The high wall will remain as is, for review by Owner's arborist at a later date.</p>

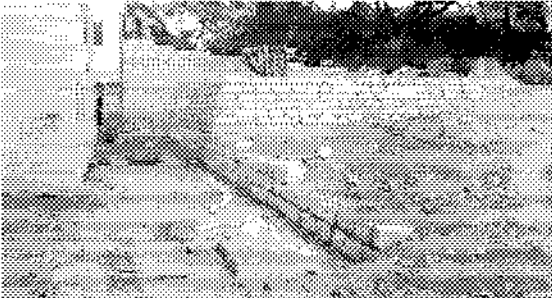
<p>- High wall west of Building 3 elec meters is skewed further west than designed, and might create an encroachment into the CRZ of the large live oak in this zone.</p>

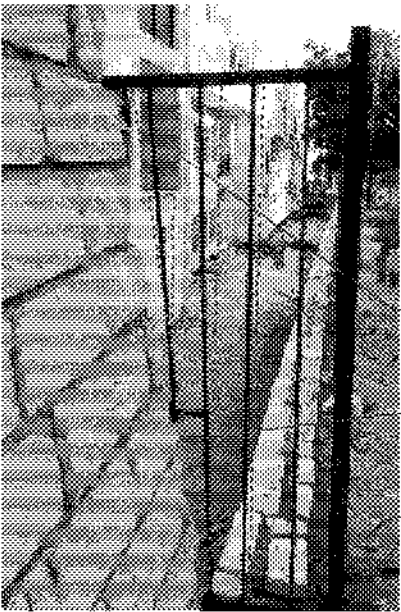
Location	Item	Description	Photo
Community Space, BCR/IDF	#3	Weis & BCS discussed the need to house an HVAC fan unit within the closet. Mounting the unit high & horizontal above the closet was ruled out due to access & duct routing problems. Owner, Weis, BCS agreed that vertically mounting the unit in the east corner of the closet is preferred. BCS prepared a sketch for Owner's internal review with IT staff.	
Wilson perimeter fence	#4	Correct non-plumb pickets @ stone wall connection, SE corner of Building 3.

<p>1 partial ht picket, connect to sloped picket</p> <p>1 picket match slope of stone wall, full height, approx 1"-2" gap to stone</p> <p>3 vertical pickets, eq spacing to fill bottom rail</p>
Site Driveway, north end	#5	Water leak noted @ base of tall stone retaining wall, near northwest corner of Building 2. Water is bubbling up & flowing steadily @ approx .25-.5gpm @ the seam between sidewalk & wall, below the weeps.

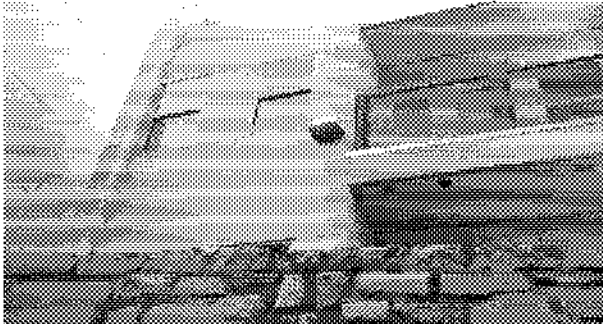
Location	Item	Observation	Action
Building 2, North end exterior	#6	PCO-64 wallpack light shields were not fabricated to design dimensions. The front lip overhang is significantly shorter on the 2 north-facing Building 2 lights.

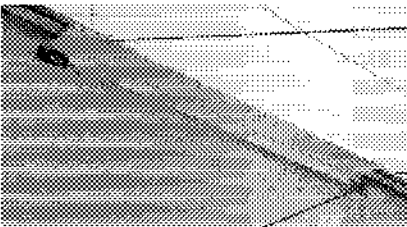
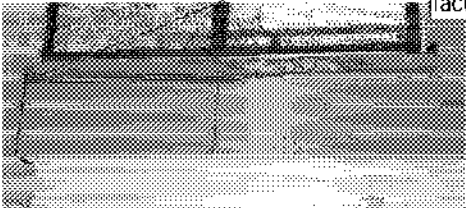
Exterior metal flashing	#7	BCS reviewed 3 exterior flashing mock-ups, with minor adjustments noted below. <ul style="list-style-type: none"> - Base of stucco wall above garage concrete wall - Base of aluminum edge @ all topping slabs - Base of hardiepanel fascias @ exterior stairs

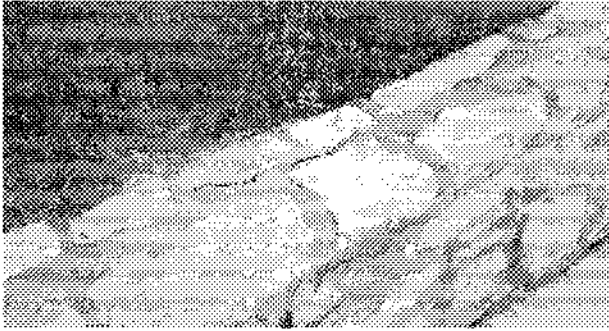
Location	Unit	Observation	Action
Site	#1	Repair cracking & damaged mortar @ retaining walls

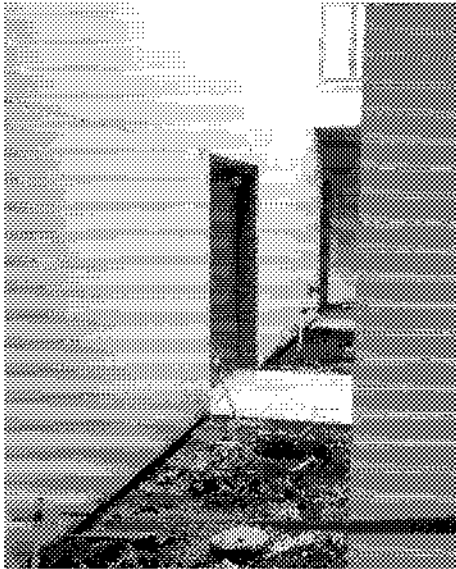
Building 4, Ground Floor	#2	<p>Entry to Theater/Classroom is not protected overhead, and is open to sky above. Original CDs call for a framed canopy, similar to the top floor unit entrances (A4.01 detail bubble). Because this is expected to be a high-use public entry, and it is a double door at the ground floor, BCS feels that overhead protection is critical and recommends that the full canopy be installed. We also understand that with residents already occupying this building, Ownership may prefer a less disruptive & mess-intensive solution, in which case the bent-steel canopy used at the mail & Kitchen areas would be a possible alternative.</p>

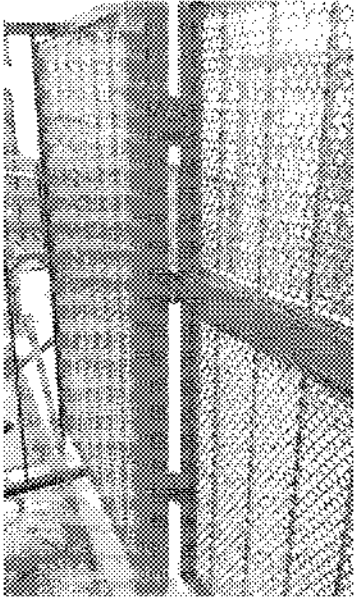
Wilson Street Perimeter Fence	#3	<p>Gates should be self-closing but were observed to be sitting open without being propped.</p>

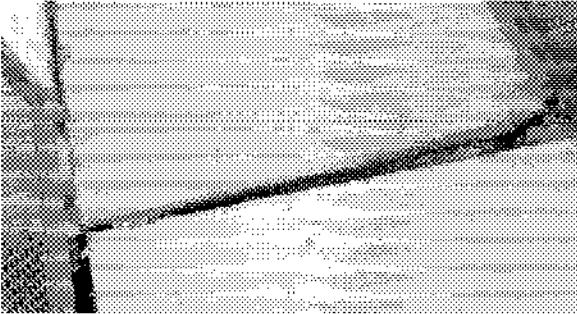
Catwalk	#4	<p>Catwalk is missing an expansion joint cover plate.</p>

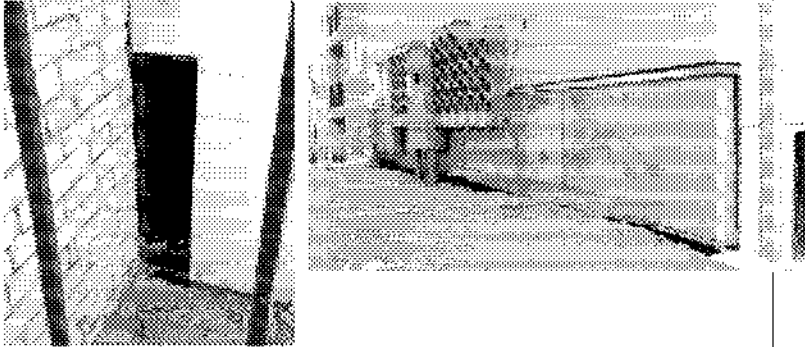
Building 3, SE Corner	#5	<p>The exterior wall near the meter bank is only partially stucco-ed, the rest has exposed concrete, metal trim, and drain mat. Also, the SE corner at Level 3 has exposed waterproofing near the retaining wall. Confirm both of these locations will be finished in stucco to match the remainder of the building.</p>

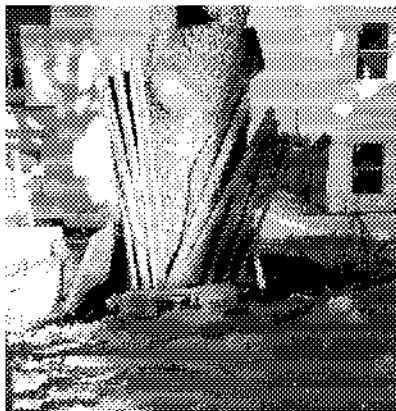
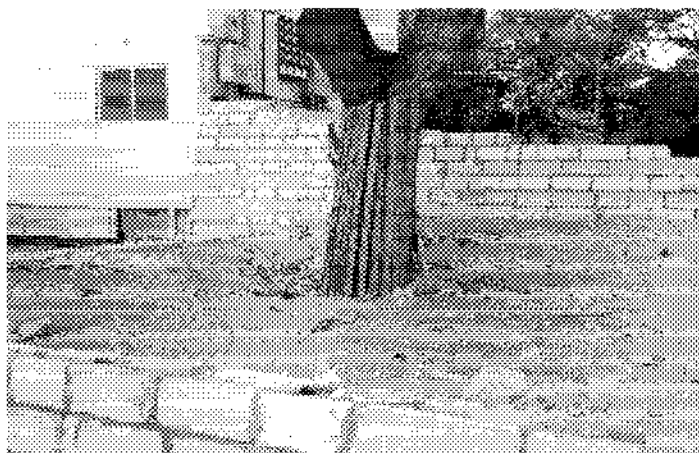
SE Site #6 Tree protection around some heritage-sized oaks has been removed or is falling apart, and materials are stacked at the base of the trees. Tree 306 appears to have approx 12" of fill dirt within inches of it's trunk, which is prohibited by CoA ordinance.

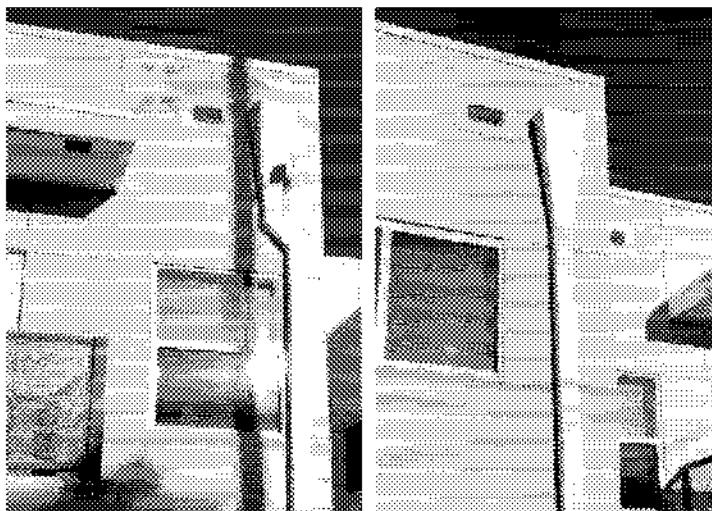
Exterior #7 Observed dented downspout collector heads along Wilson Street, Building 4.

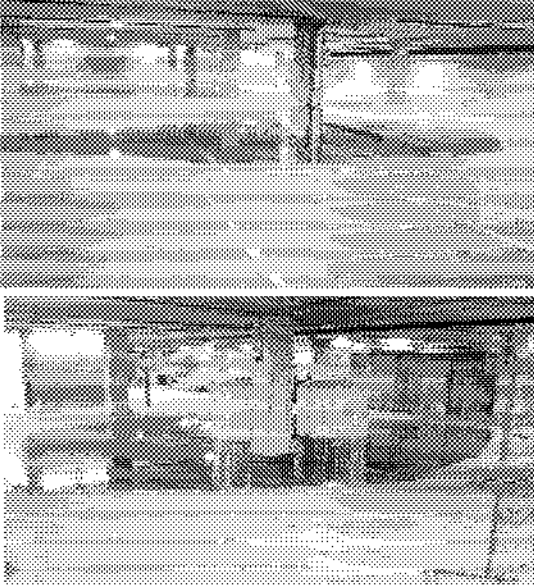
Location	Unit	Observation	Notes
Garage	#1	<p>Significant amounts of water observed ponding on level G1, sometimes around equipment & materials. Remove any resulting staining or discoloration.</p>

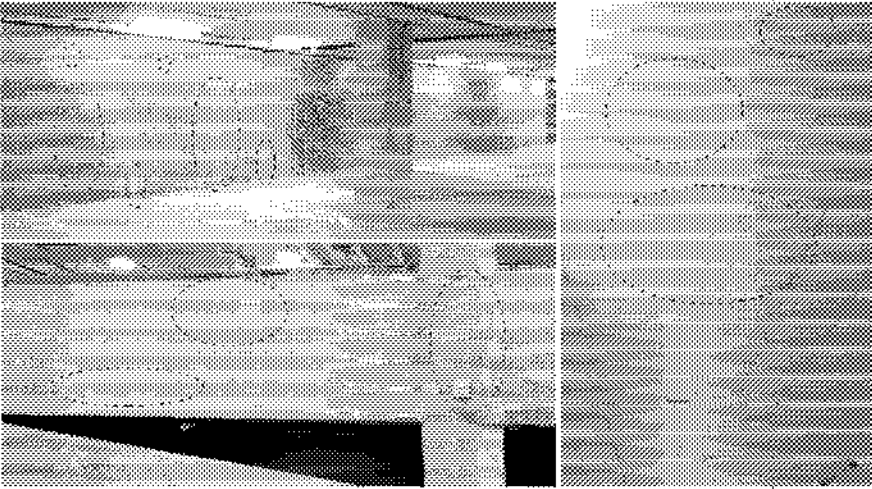
Garage	#2	<p>Clean layout markings & stain marks from G1 walls & ceiling, prior to turnover.</p>

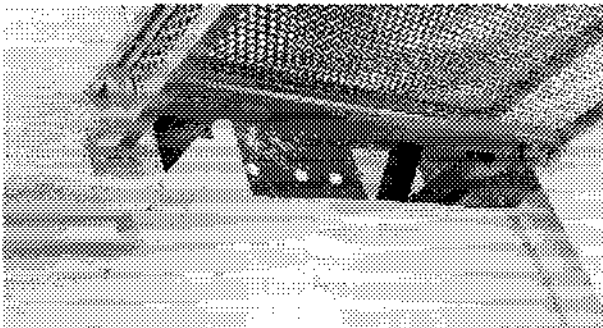
Building C, North end	#4	There is a large gap (12" wide, approx) between podium edge & catwalk, a location that is accessible to tenants. Recommend placing a temporary barricade over this opening, until the concrete topping is poured & the gap is reduced to a code-compliant size (4" sphere).

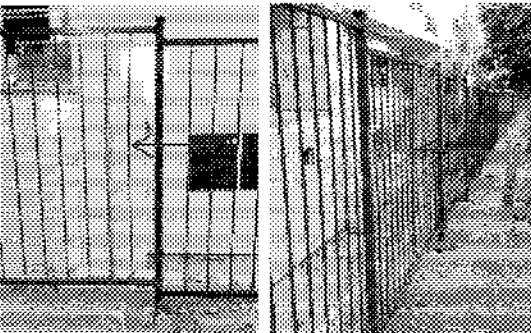
Wilson Street Perimeter Fence	#5	Joe Tracy, David Liddick, and Travis Lucy reviewed the gates along Wilson Street. The catwalk gate was observed to be functioning as intended, with good self-closing strength & latching. It is equipped with self-closing hinges and a 'gate spring' device. This gate will serve as the approved mock-up basis for the others.	
Wilson Street Perimeter Fence	#6	Several panels have bent pickets

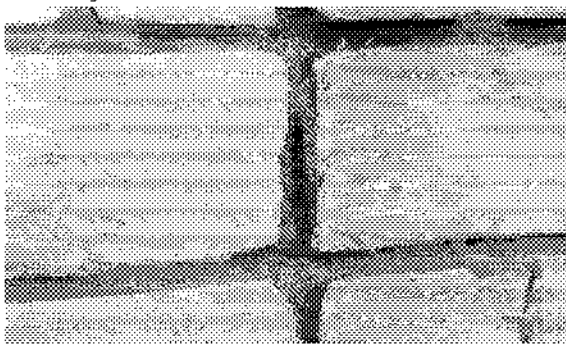
Location	Item	Observation	Remarks
Pavilion Area	#7	Retaining wall along Wilson has a piece of OSB or plywood protruding from a mortar joint

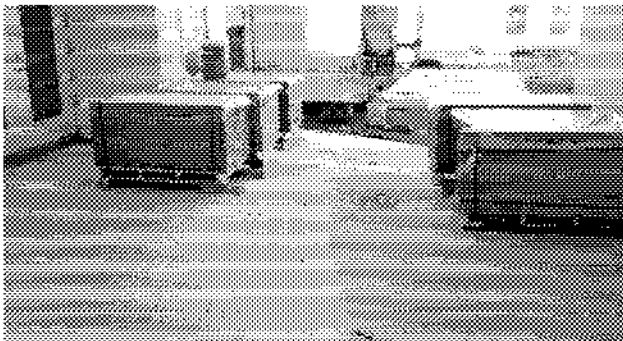
Podium Deck	#8	Avoid stacking paver pallets in close proximity on the podium deck. SCA's stated deadweight limit for the podium deck is 100psf, and each pallet of 11 pavers is estimated at +/-370psf. Substantial topping slab cracking was observed in the immediate vicinity of these pallets.	Weis was in the process of redistributing the pallets at time of departure.

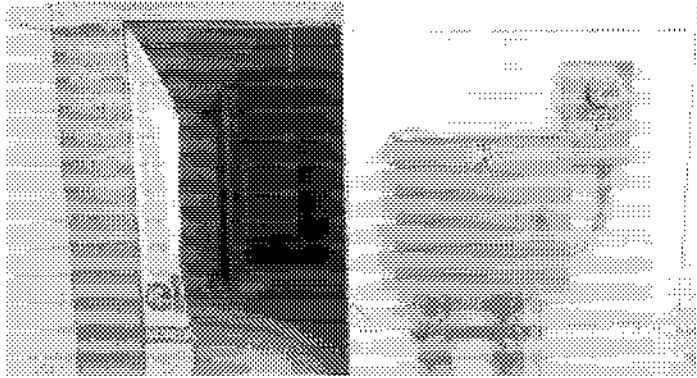
Location	ID	Report Item	Notes
Stair 1 North, Level 3	#1	West-facing stairwell egress door appears to lack TAS-required clearance on strike side, due to fire pump cabinet.

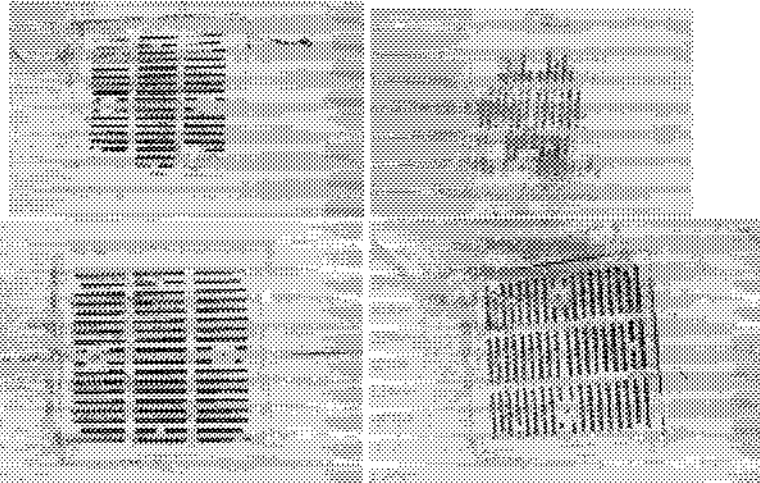
Garage area drains	#3	All garage area drains are stained and at least partially clogged with concrete.

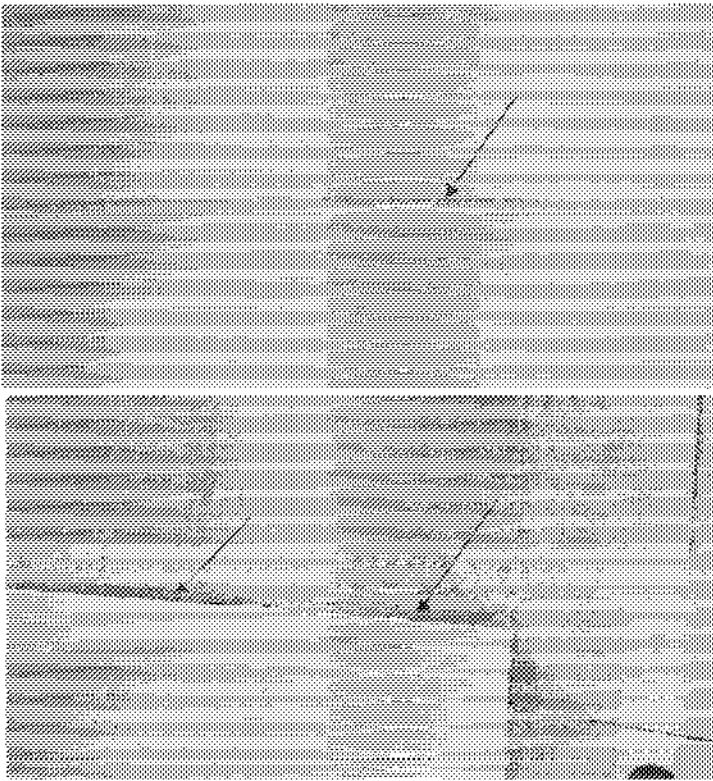
Garage, floor joints	#4	<p>Form board edges protrude above the finished floor surface at some columns and shear walls within the garages, preventing sealant joint installation and allowing the possibility of water penetration</p>

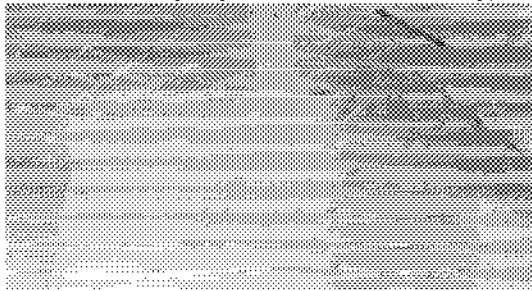
Garage floor	#4	<p>Mortar stains on garage floor near CMU walls, typ.</p>

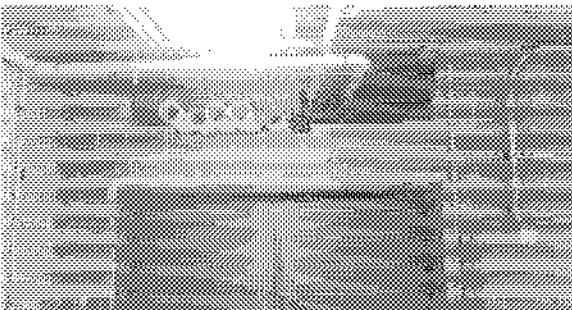
Garage Equip Room	#5	<p>Per CDs, perimeter wall of Equipment Room is to be constructed per UL 905, 2hr fire-resistance rating. Large hole above door for piping penetrations will need to be infilled per the UL design.</p>

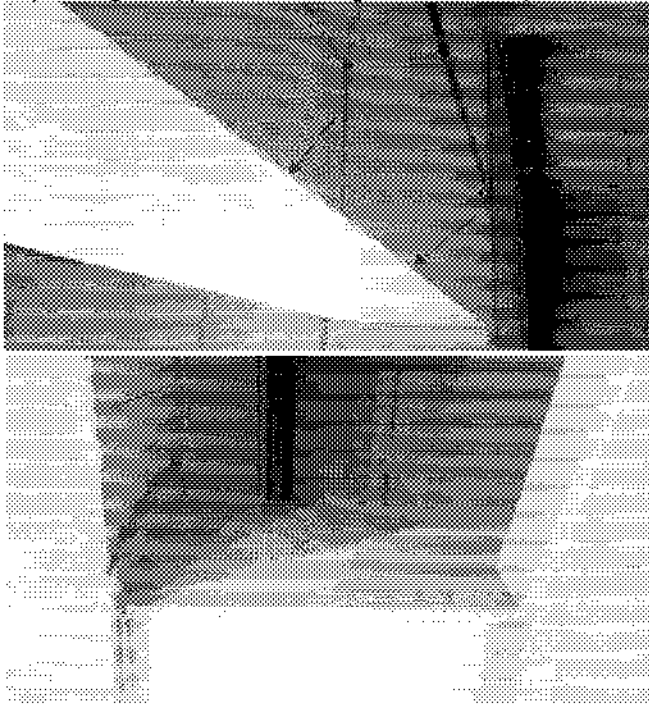
Location	Item	Description	Photo
Garage Ceiling	#6	Repair rough, chipped concrete edge above G1 ramp

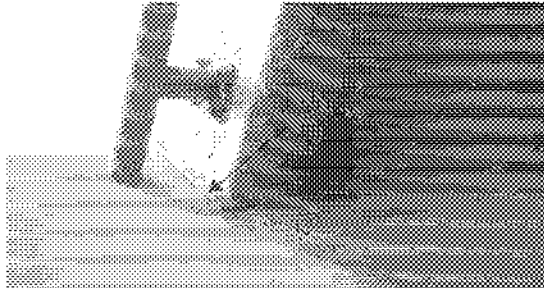
Garage, ramp area	#8	Form boards visible at 1/2 wall & column meetings in several locations. Cut form board back below wall & provide sealant joint

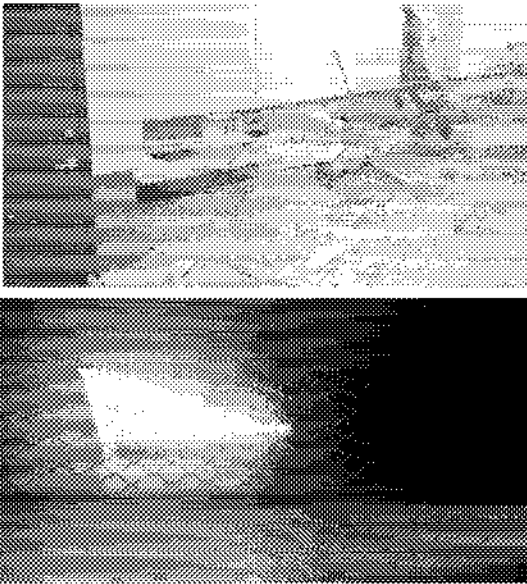
Location	Item	Observation	Photo
Garage Air Shafts	#9	Both air shafts were observed to be covered at time of inspection, due to nearby surface-level site work. Maintain code-required monitoring and air change at all times when garage is occupied and used by tenants.

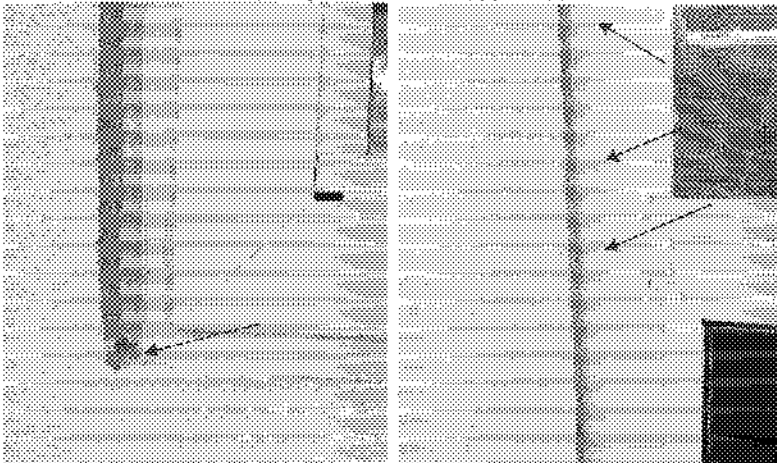
Windows , Phase 1A	#11	At some locations, window frame perimeter sealant joints were observed to be discontinuous and/or poorly tooled and sloppy in appearance.

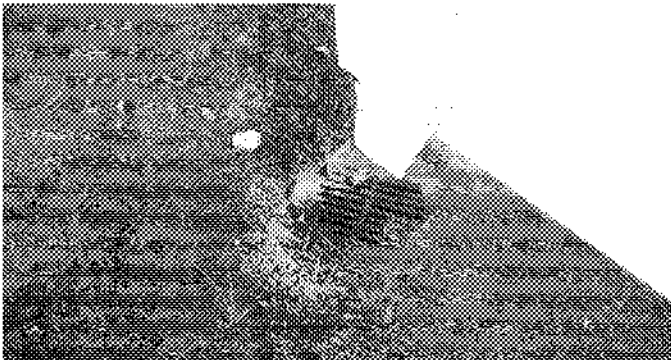
Downspouts	#13	Concrete and/or stucco clogging seen on some downspout drain covers.
